SUPERFUND FIVE YEAR REVIEW REPORT

LEE'S LANE LANDFILL

LOUISVILLE, JEFFERSON COUNTY, KY

JUNE 2003

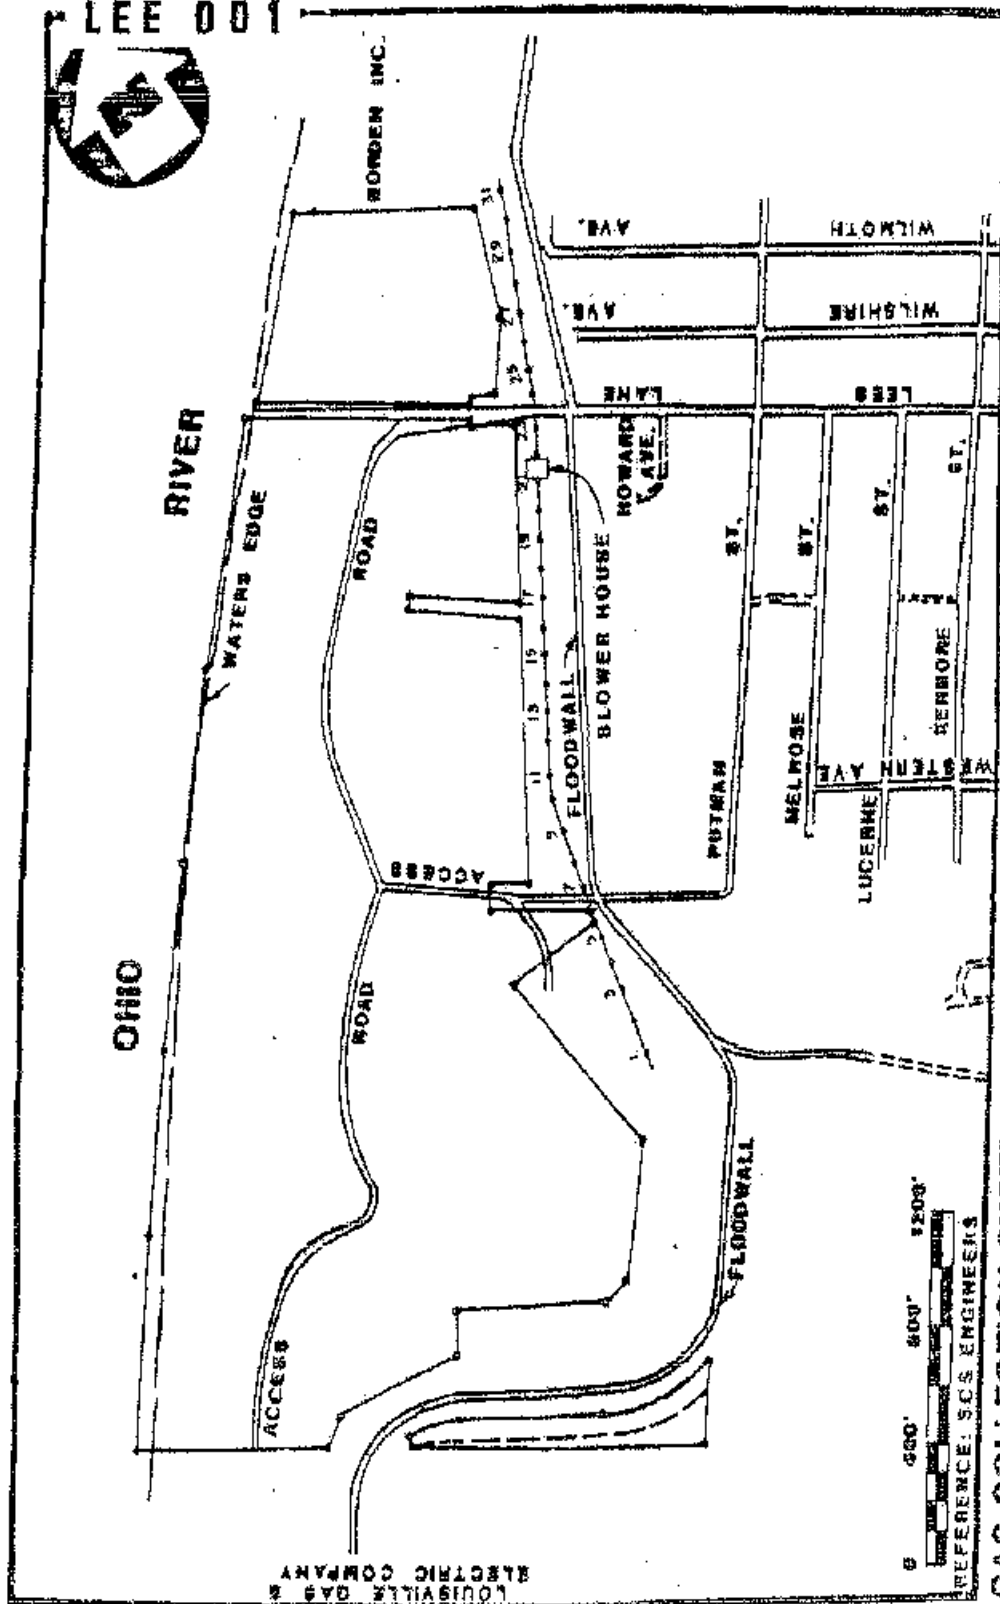
Figure 5
Subsurface Gas Collection System
Lce's Lane Landfill

16. The blower house for the subsurface gas collection system has many pipes and controls. Mr. Mike Humphrey of MSD indicated that the only maintenance that MSD performs is to replace burnt-out motors. The system runs continuously. He said MSD has no operations and maintenance manual for the system, no as-built drawings, and generally has no way of adequately monitoring the performance of the system, see Photographs 4 and 17, and Figure 5.
